Engineering Evaluation/Cost Analysis

**Non Time Critical Removal Support
Gulfc0 Marine Maintenance Superfund Site
906 Marlin Avenue
Freeport, Brazoria County, Texas
Contract No. EP-W-06-004
EPA Identification No. TXD055144539**

February 2011
Revision: 02
EA Project No. 14342.67

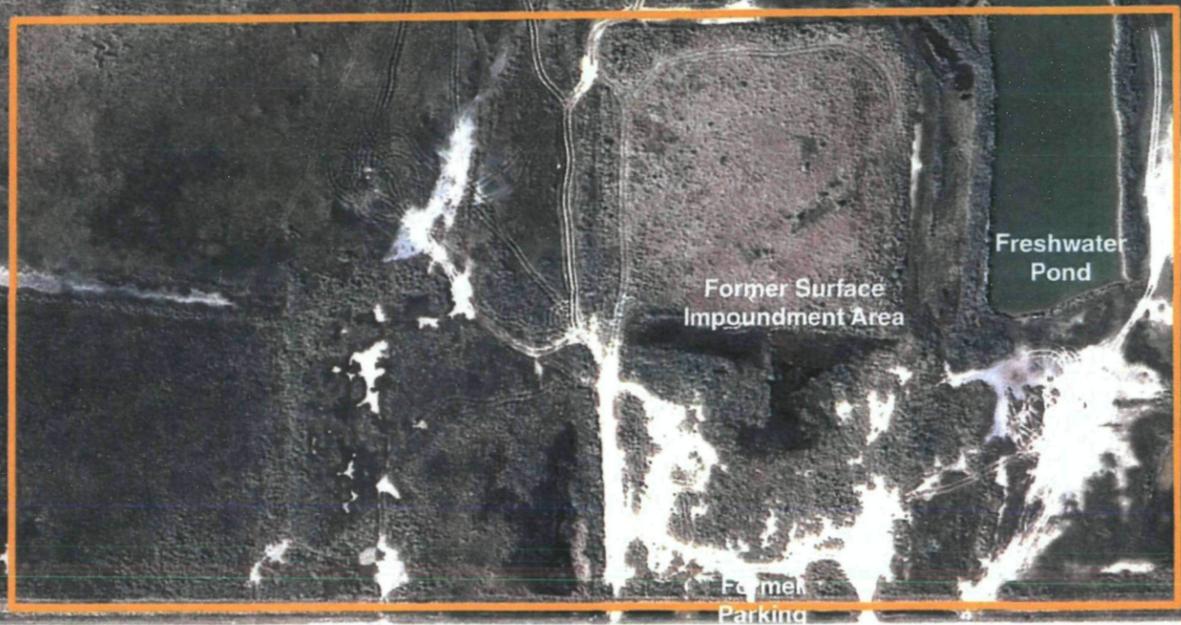
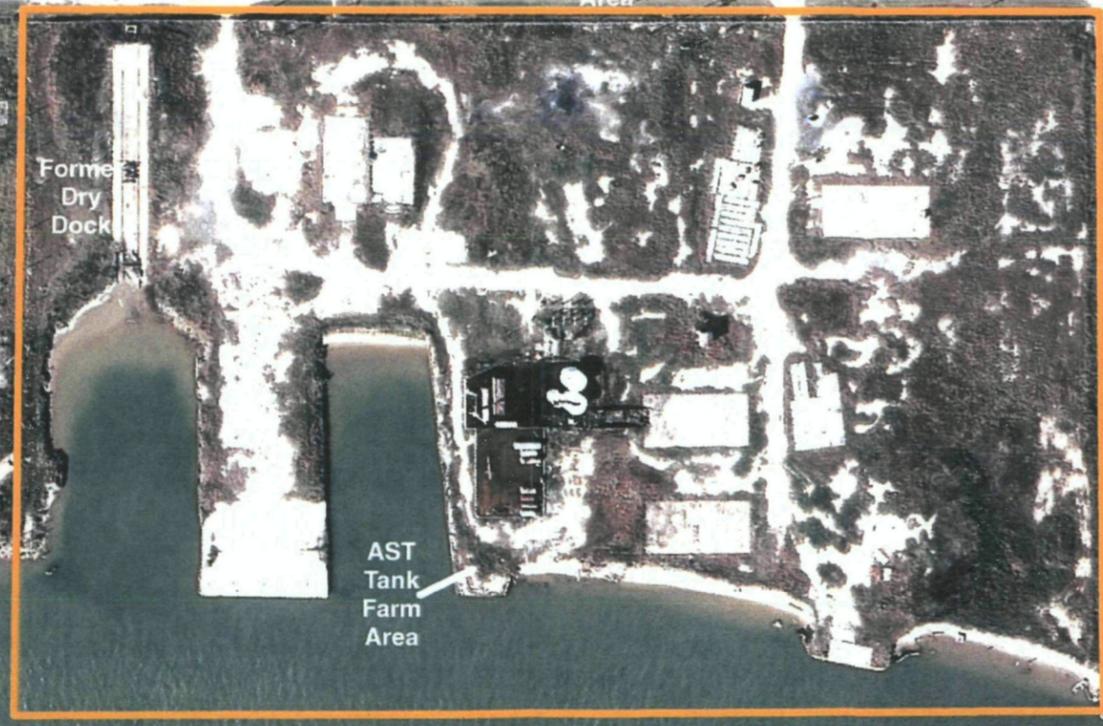
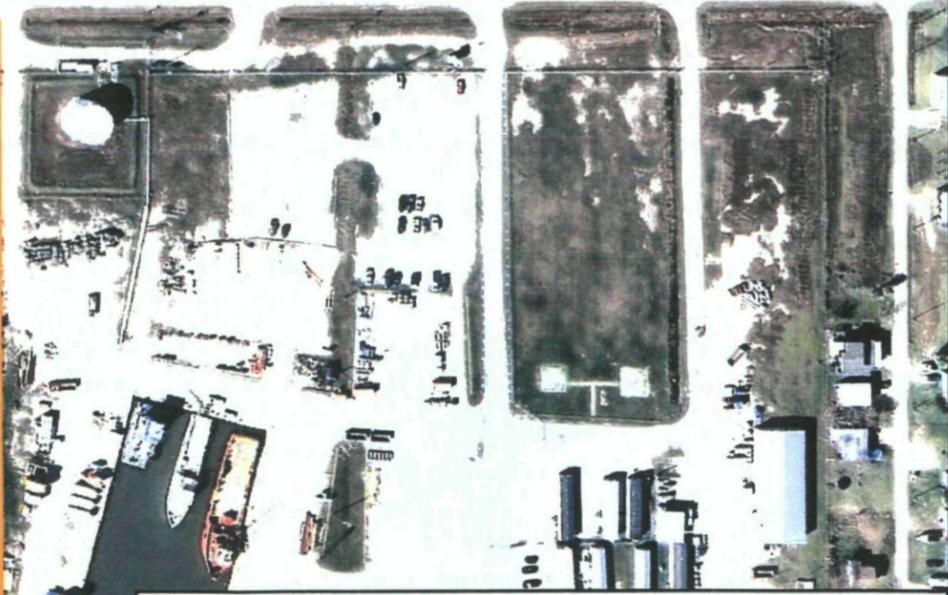
Path: G:\Gulfco\MXD\MBReport\MXD\Figure2.mxd

Marlin Avenue divides the site into two primary areas (Figure 2). For the purpose of descriptions in this report, Marlin Avenue is approximated to run due west to east. The property north of Marlin Avenue (the North Area) consists of undeveloped land and closed surface impoundments, while the property south of Marlin Avenue (the South Area) was developed for industrial uses with multiple structures, a dry dock, an above ground storage tank (AST) farm, and two barge slips connected to the Intercoastal Waterway. This SERE addresses only the area north of Martin Avenue.

The small irregularly shaped area immediately north of the Fresh Water Pond (Figure 2) is a salt panne, a shallow depression that retains seawater for short periods of time such that salt accumulates to high levels over multiple tidal cycles.

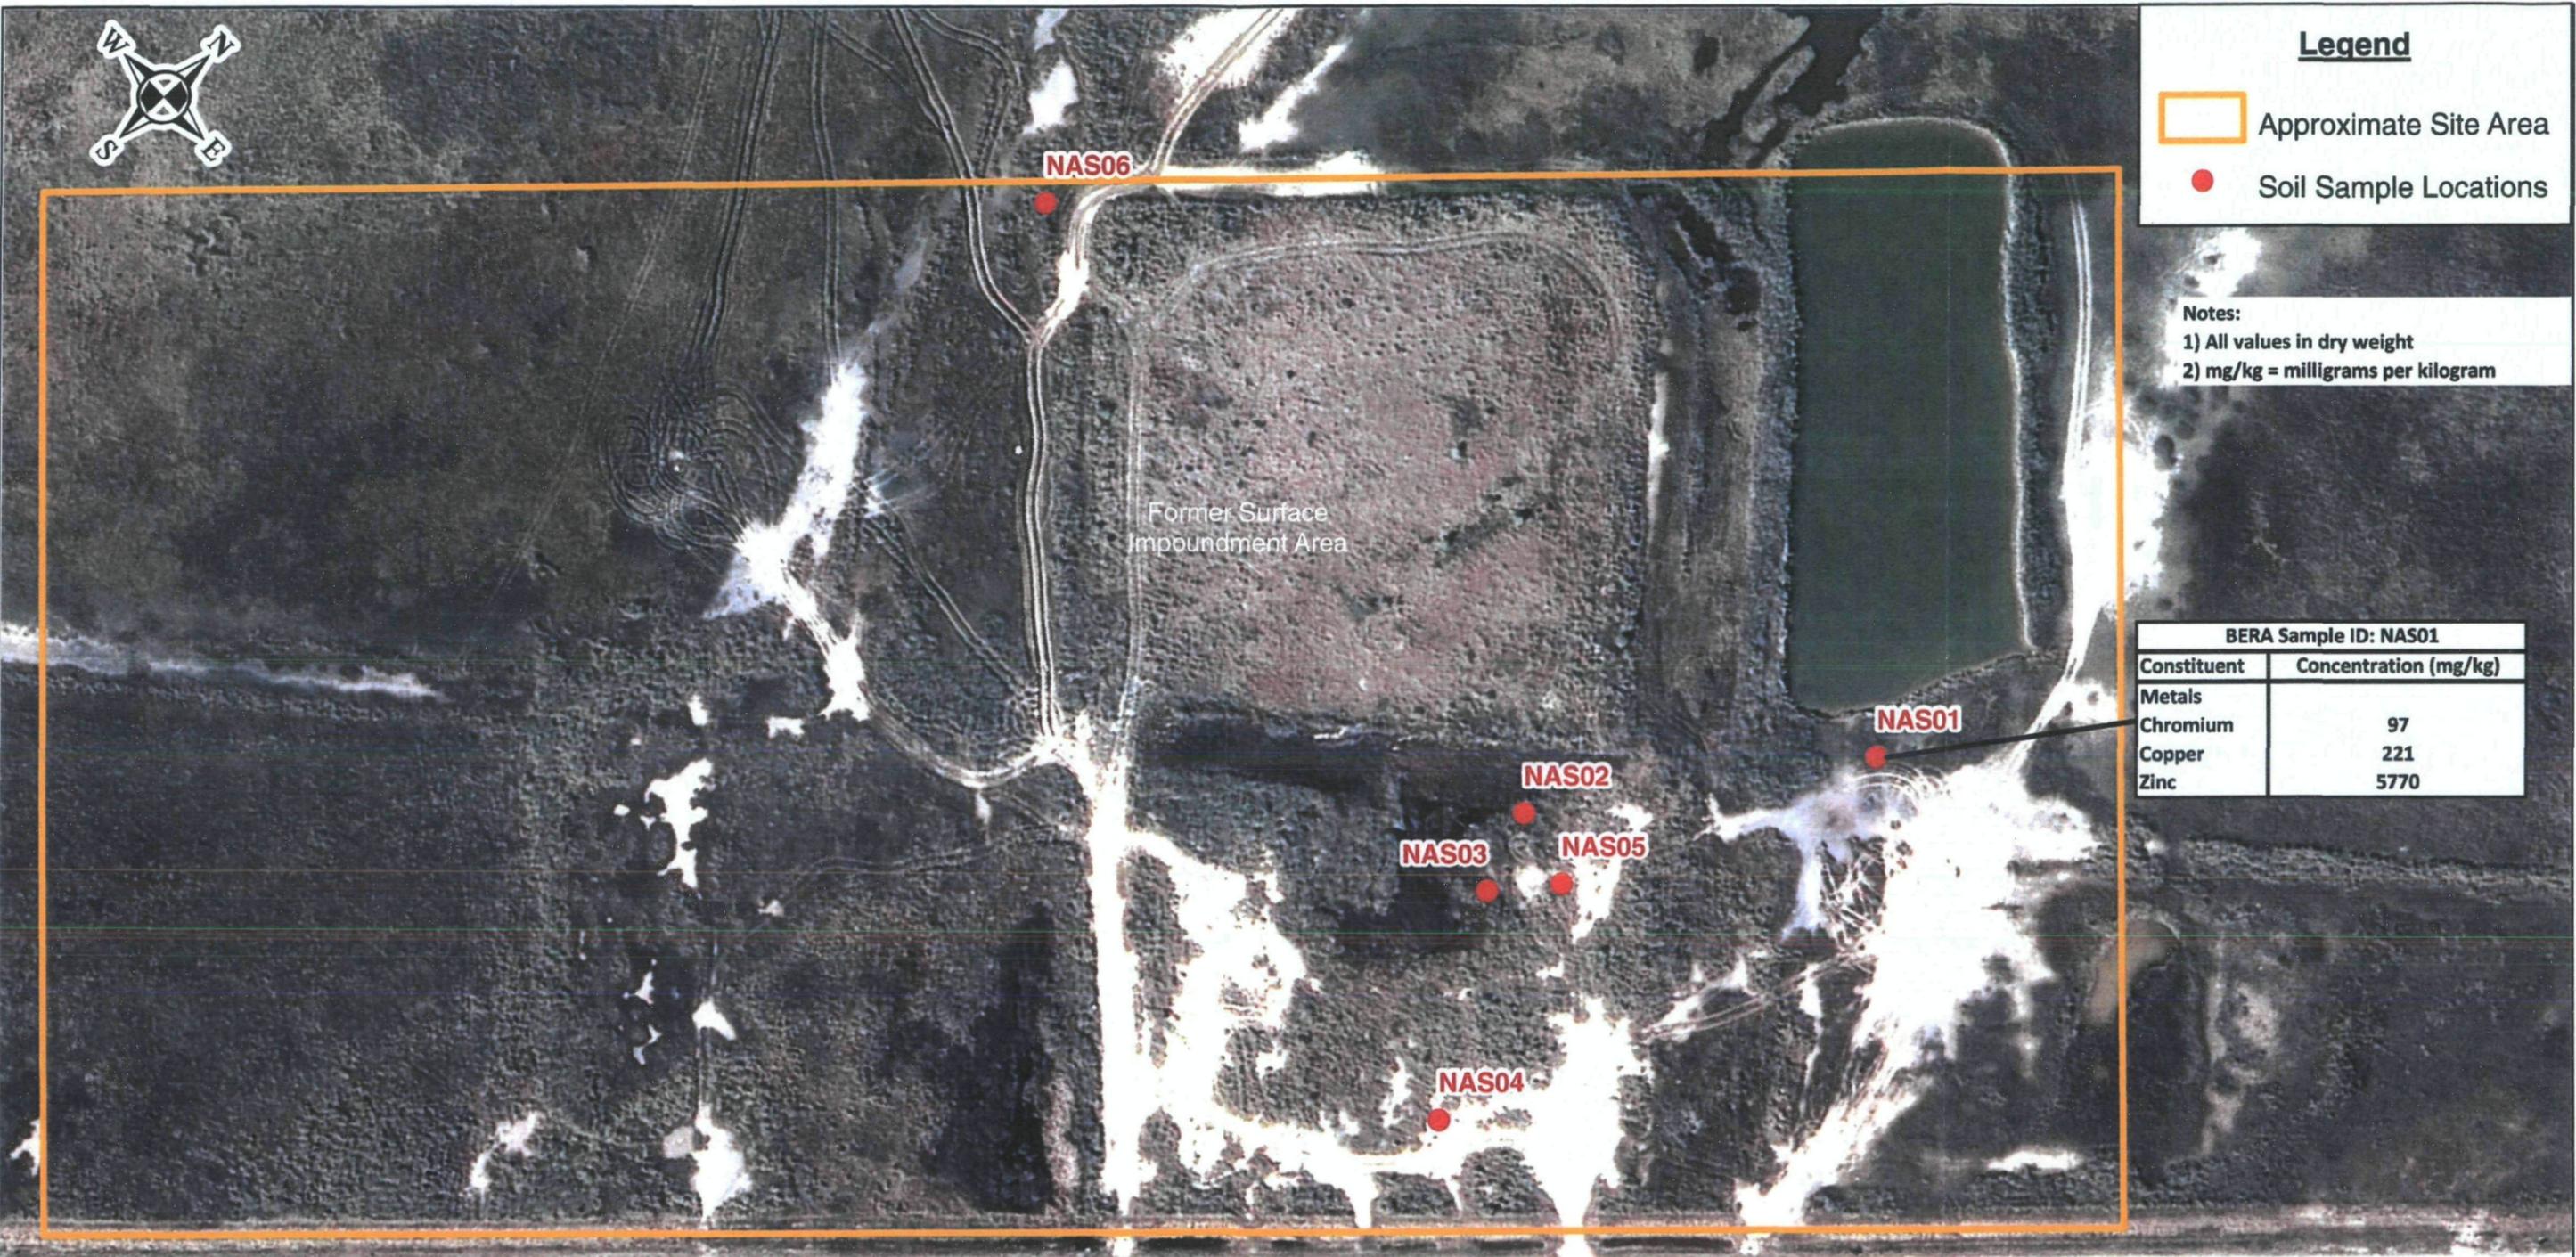
Gulfco Marine Maintenance Superfund Site
Baseline Ecological Risk Assessment
 Sample Locations and Potential Stressors in North Area Soils

Notes:
 1) All values in dry weight
 2) mg/kg = milligrams per kilogram

BERA Sample ID: NAS01	
Constituent	Concentration (mg/kg)
Metals	
Chromium	97
Copper	221
Zinc	5770
